## COVENANT HOME SERVICES

# Sample Inspection Report

**123 Example Street, Sample City, WY**

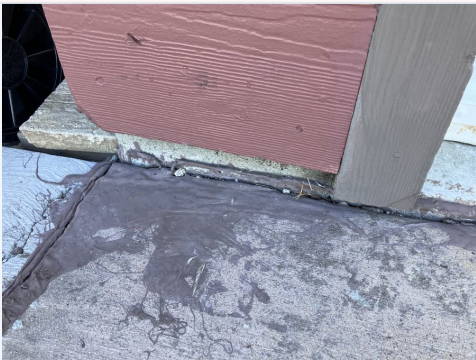
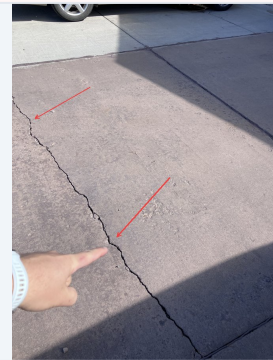
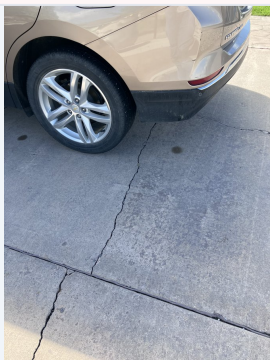
**Cracked or settled surface** Deficiency Maintenance

The driveway showed cracking or settlement. This is common as paved surfaces age; open cracks admit water that widens them through freeze and thaw.

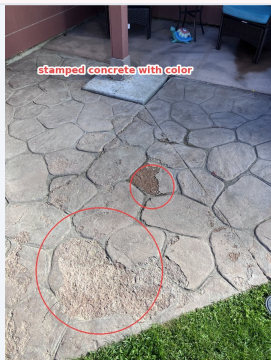
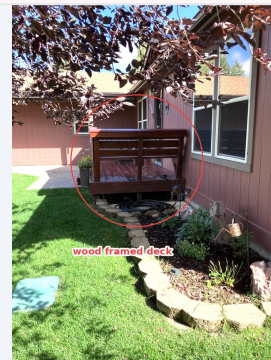
⚠ Cracking or settlement **Deficiency** **Maintenance**

📋 Walkways showed cracking or settlement without a significant change in walking surface height.

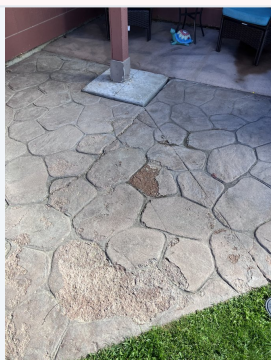
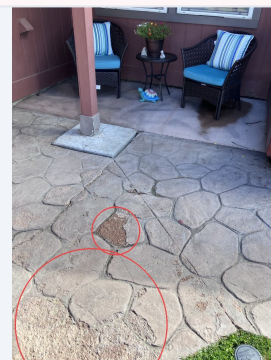
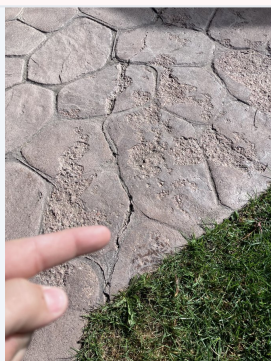
⚠ Concrete Surface Deterioration **Deficiency** **Maintenance**

📋 Concrete Concrete surfaces showed deterioration, including surface scaling, flaking, or localized material loss. This condition is commonly associated with age, moisture exposure, freeze-thaw cycles, deicing salts, or improper finishing. Continued deterioration may allow additional moisture intrusion and accelerate surface damage.

💡 Recommend repairing deteriorated areas as needed and sealing exposed concrete surfaces with an appropriate concrete sealer. More extensive or deep deterioration should be evaluated by a qualified concrete contractor to determine the appropriate repair method.

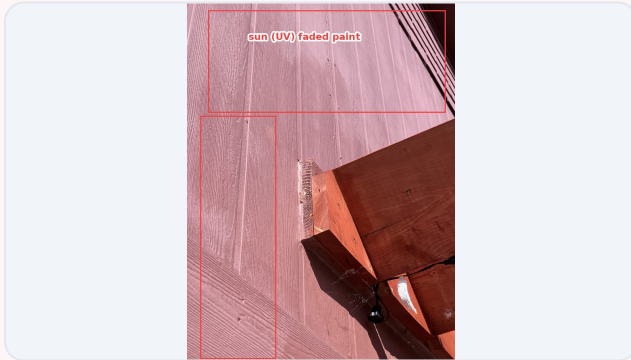
⚠️ Finish weathered **Deficiency** **Maintenance**

📄 The finish on trim and fascia boards was peeling or weathered, leaving the wood more exposed to moisture.

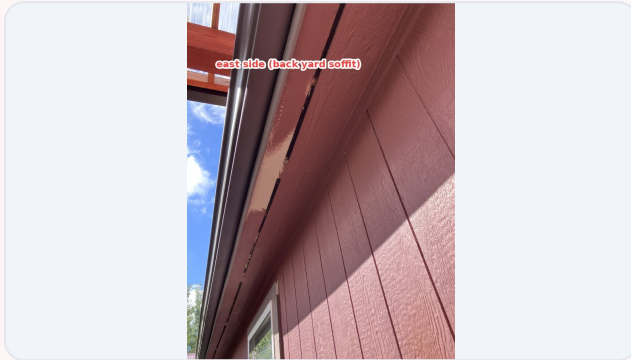
⚠ Missing Paint **Deficiency** **Maintenance**

- 📄 Paint was missing or deteriorated at one or more exterior surfaces, leaving the underlying material exposed. Unprotected surfaces can absorb moisture and may deteriorate more quickly, particularly in areas exposed to weather.
- 💡 Recommend properly preparing and repainting or sealing exposed surfaces to protect the material from moisture and weathering. Repair any damaged substrate as needed before applying the new finish.

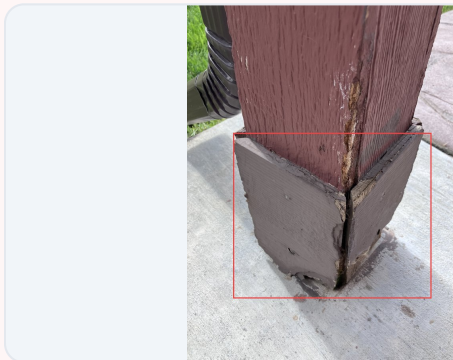
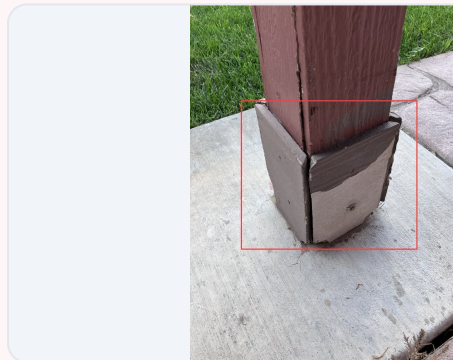
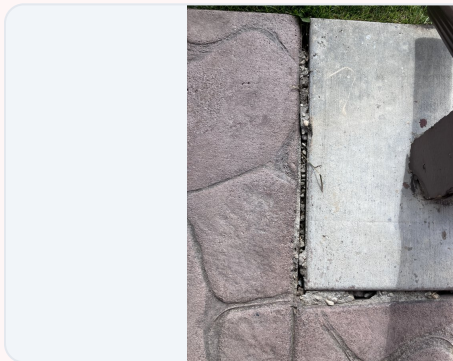
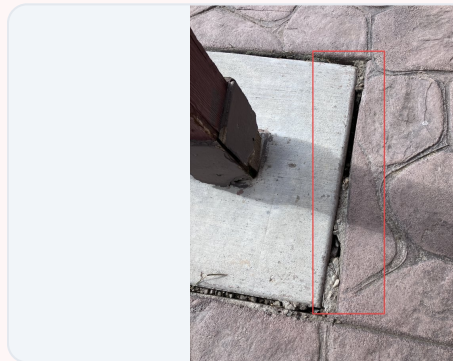
⚠ Wood trim deteriorated **Deficiency** **Deficiency**

- 📄 Trim around the two (2) roof overhang posts are badly deteriorated.
- 💡 replace trim, seal with exterior grade caulking, paint

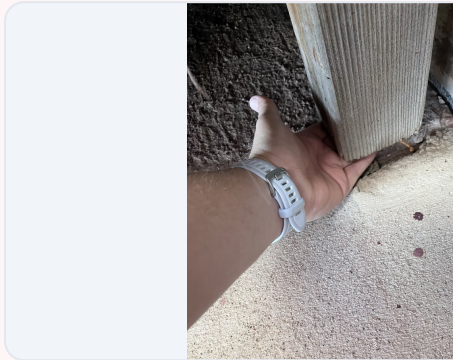
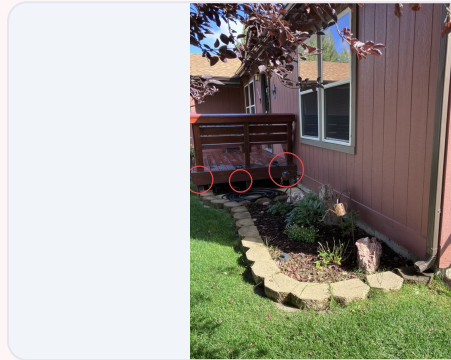
⚠️ Structural damage **Deficiency** **Safety**

- 📄 Deck or porch structural components were damaged, decayed, or deteriorated. A weakened deck can fail suddenly under the weight of people gathered on it. The 4X4 post (2 observed) supporting the corner (west side) of the from deck appear to be unsupported; it is assumed that the deck joists are accounting for the majority of the load
- 💡 Have a licensed contractor add sufficient support to the deck posts. Deck in general is near it's end of life for a typical wood framed deck.

Handrail on front deck appears to be loose; Most likely a result of the decking, ledger, and post conditions; only present on the front deck location.

💡 recommend a contractor to mitigate bearing and deck ledger issues. This is not currently a safety concern. But left un-attended, has the potential for deck failure and railing failure. The future life and condition of the railing cannot be determined.

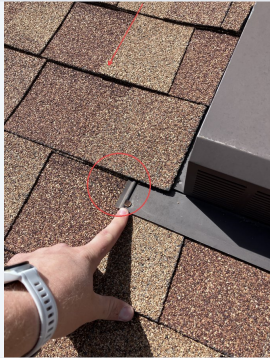
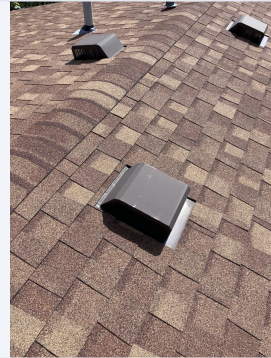
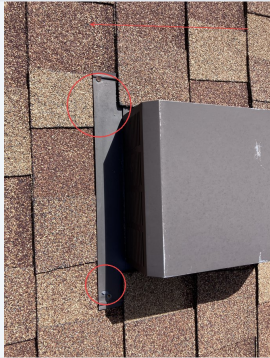
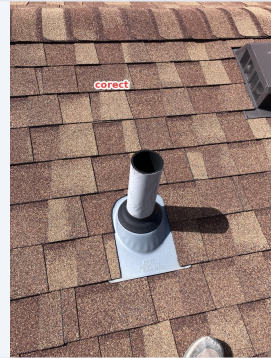
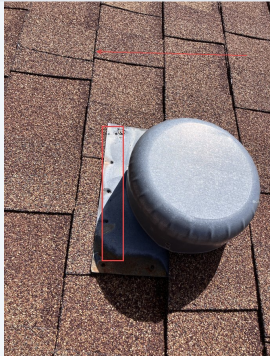
⚠ **Boot attachment** Deficiency Maintenance

Metal flashing are all installed correctly. The fastener material (nails) used could not be determined (steel, galvanized, or other). The fasteners are showing deterioration more than what is considered normal for the age of roof. Some flashings are poorly installed but not leaking at the time of inspection.
- 💡 replace fasteners with appropriate galvanized roof nails only. A professional roofin contractor should perform the install. Nails are to be added to the downside of the roof penetration

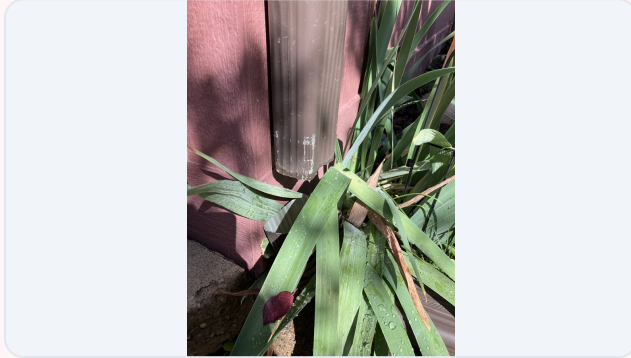
⚠ Downspouts discharge at foundation **Deficiency** **Maintenance**

📄 Downspouts discharge next to the foundation. Concentrated roof water at the base of the wall is a leading cause of basement dampness. Located at the East corner of building; the downspout was disconnected; allowing water to drain against the foundation. Prolonged water exposure to foundation systems can cause serious structural damage.

💡 re-attach downspout to the vertical section of downspout. install galvanized sheet metal screws.

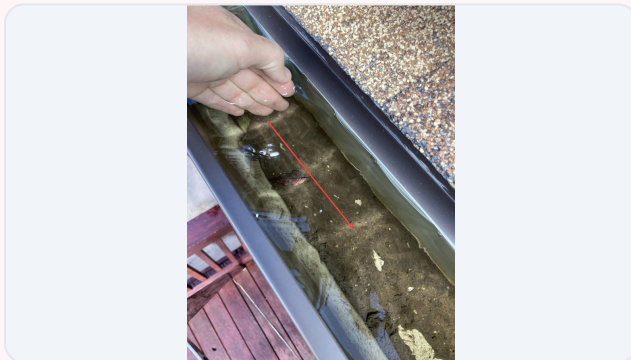
⚠ Gutters clogged **Deficiency** **Maintenance**

📄 Gutters were clogged with debris. Regular cleaning is recommended to ensure proper roof drainage. Location is on the Street side gutter only; clogged downspout on the west Southwest Corner

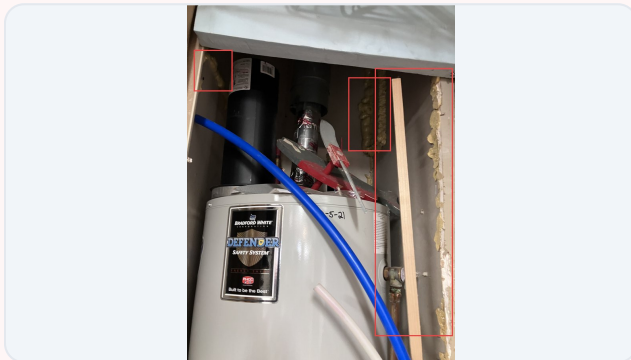
Opening in separation Deficiency Safety

The originally constructed firewall appears to have been modified. Access to the space was limited for first investigation.

Removed items and confirm that there are no penetrations in the firewall

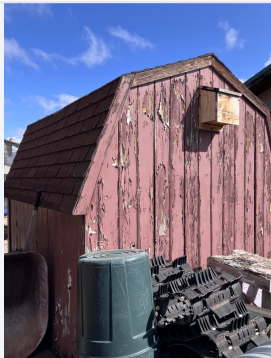
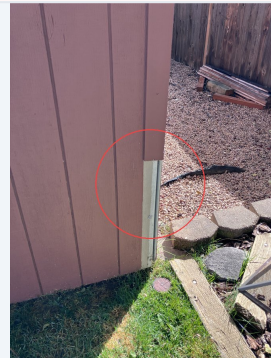
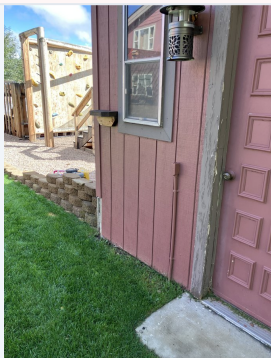
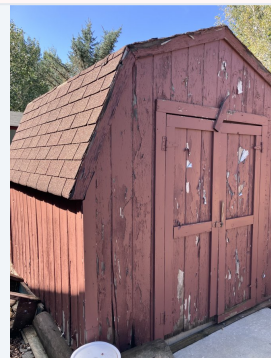
⚠ Visible deterioration **Deficiency** **Deficiency**

📄 An included detached structure showed damage or deterioration including the paint; trim, and roof areas.

💡 recommend replacing missing trim; scraping peeled paint, paint structures, and re-apply shingles.

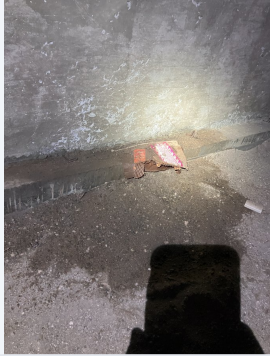
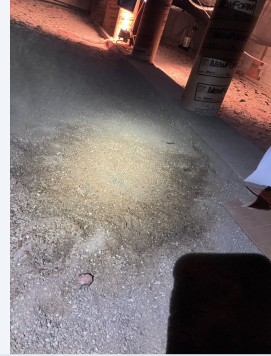
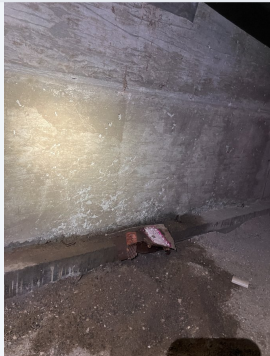
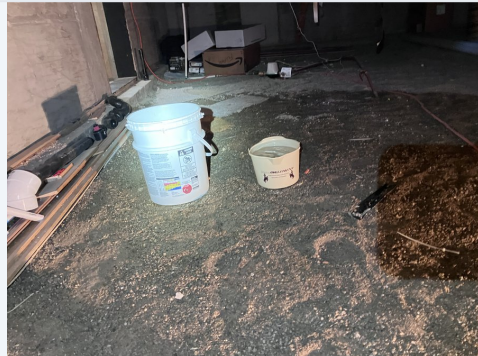
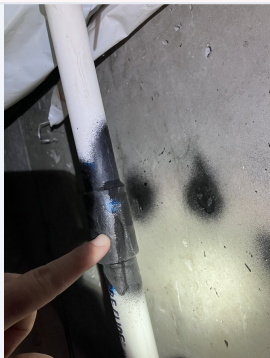
⚠ Active moisture **Deficiency** **Deficiency**

- 📄 Active seepage, dampness, or standing water was present in the basement or crawlspace. Persistent moisture damages stored items and finishes, supports mold growth, and can deteriorate the structure over time.
- 💡 Fix leaks in the water irrigation system (at least 2). Leave crawler access door open for a minimum of 48 Hours after the leaks are repaired.

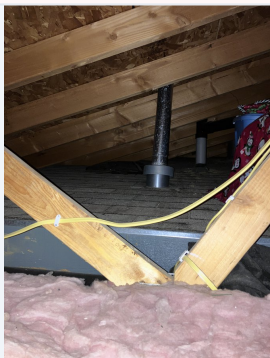
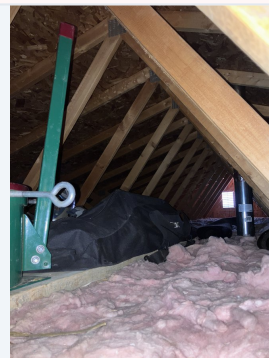
⚠ Coverage thin or uneven **Deficiency** **Maintenance**

📄 Insulation coverage was thin, uneven, or missing in areas, specifically over the garage area. The garage is heated, and the thinner (in comparison to the home sections) can cause a decrease in home efficiency and an increase in utility charges. Typical for heating and cooling.

💡 Add approximately 12" of batt or blown in insulation. A professional contractor should evaluate. It is also noteworthy that no remedy is required or recommended based on the usage of the garage. If the temperature and functionality of the garage is adequate for the user. Then no added insulation is recommended.

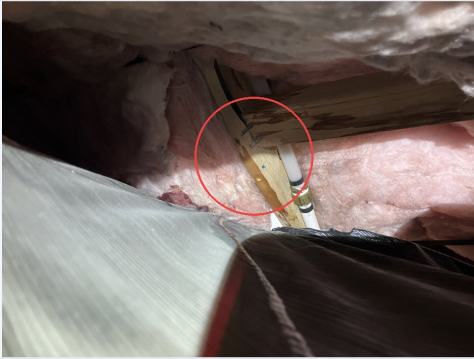
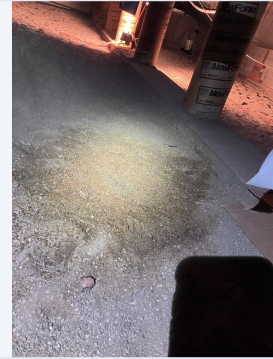
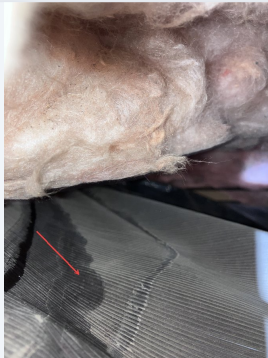
⚠ Active leak **Deficiency** **Deficiency**

📄 An active water leak was found at a pipe, fitting, or valve. Located below and near the Guest bathroom. The exact location could not be determined due to limited access of insulation.

💡 A professional should removed insulation around the leak and determine the source. Fix any leaking pipes and replace insulation to original condition.

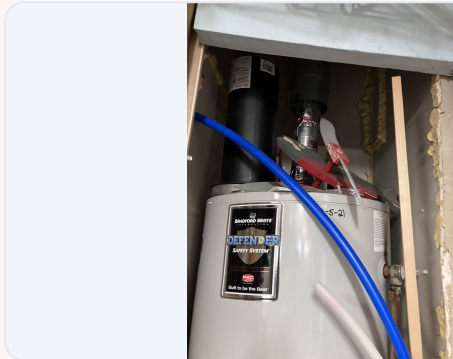
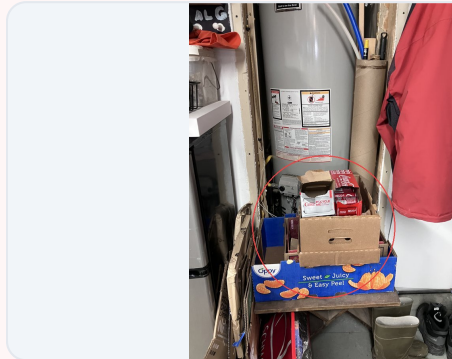
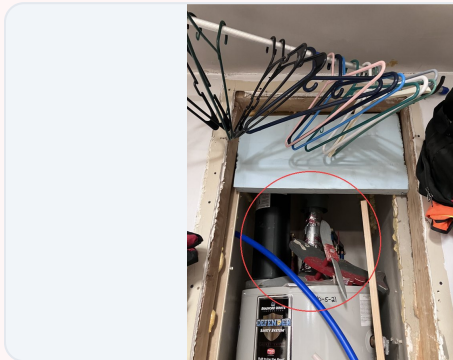
### ⚠️ Appliance Clearance Deficiency Maintenance

- 📄 Remove storage or random items from around the water heater. Items should not be placed on top of or in front of the water heater in this specific condition
- 💡 Remove items on top; leave 12" min of clear space in front of water heater; specifically the gas control and functional controls.

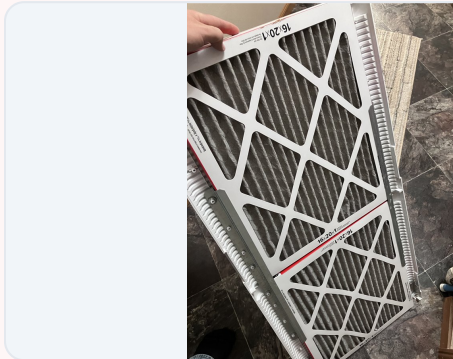
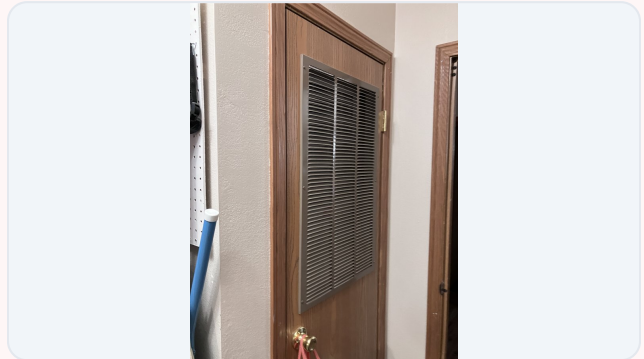
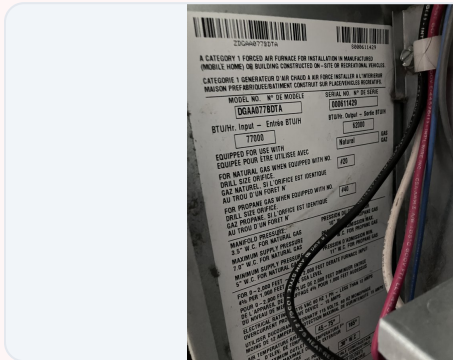
⚠ Equipment at or past typical service life **Deficiency** **Maintenance**

- 📄 The heating equipment is at or past its typical service life based on its data plate or visible age. Remaining life cannot be determined from a visual inspection.
- 💡 The furnace has been well maintained, but will or has begun to enter the typical service life. A typical furnace can expect 20 years of functional operation.

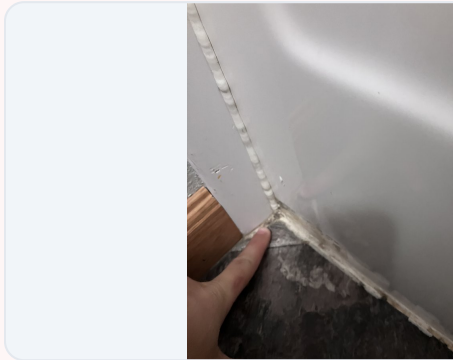
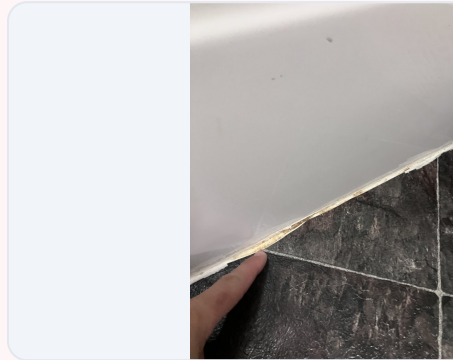
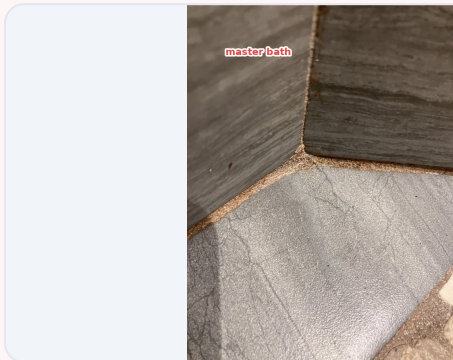
⚠️ Caulk or grout deteriorated Deficiency Maintenance

- 📄 Guest bathroom Caulk or grout joints at the tub or shower were cracked, stained, or missing in places. These joints are the maintenance line that keeps splash water out of the walls.

Master bathroom Shower; clean and maintain grout joints near the bottom of shower basin. No loose grout was present at time of inspection.

- 💡 Clean and replace old caulking as needed. The stains show that water is frequent at the tub surround, typically from splashing water. There were no leaks present at the time of inspection.
